## PROGRESS ON THE PRESERVATION OF OUR LOFT J. FREDERIC WENCHEL WINDOW

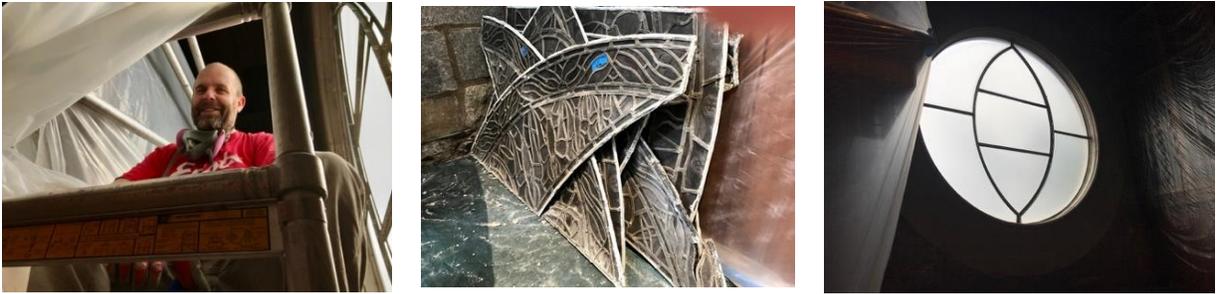
Talking with him that week, he noted that now that he had gotten up close to the window, there was more cracked glass than he expected. He said it was definitely the right time for us to get the window renovated.

Above is a photo of him working on the scaffolding in the loft, the window panels after they had been removed, and the plexiglass outer window cover which was left in place.

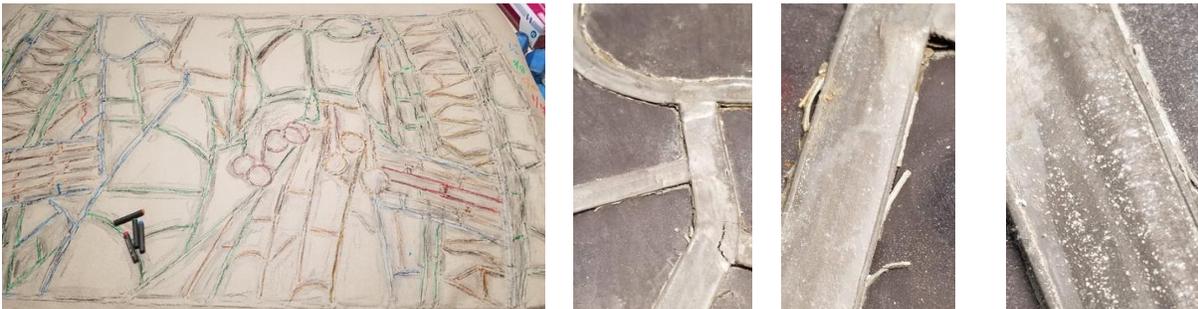
Above on the left he shows us a rubbing of the panel. The colors represent the different sizes of the leads used in the panel. He also comments on the state of the window. The next picture to the right, shows cracks in the lead, and the next shows failing waterproofing. Furthest right, there are changes in the lead due to water, creating white spots of lead carbonate.

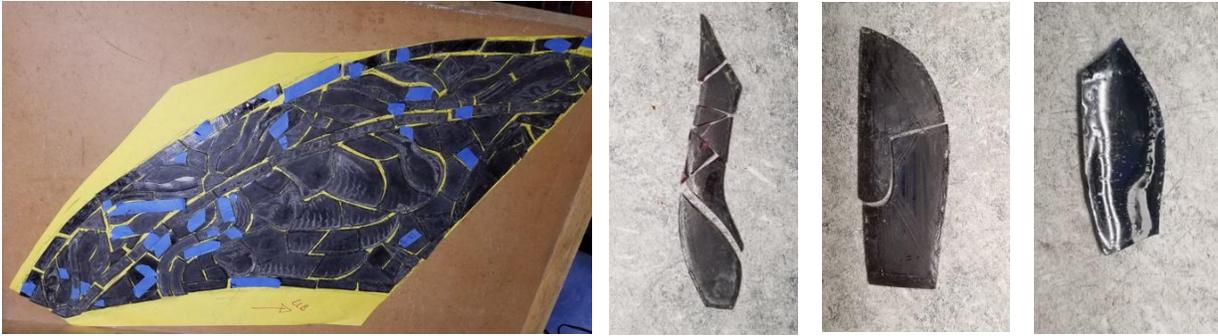
Most recently he shared with us the state of the glass and paint itself. He noted again that there is a lot more broken glass than was observable *in situ*. Many of the pieces are convex and based on the manner in which several pieces are broken, he thinks the glass was fired and cooled too quickly. This makes the glass very brittle. The brittle glass and the degree of buckling in the window, lends itself to many of the pieces of glass being broken.

Above left: One of the 11 panels. Each piece of blue tape is a broken piece of glass and the white specs are where the putty has embedded itself into the paint and will not be removed due to the paint not being fully fired into the glass. This is perhaps the worst of the panels with respect to broken glass. 2<sup>nd</sup> to the left: This piece will be edge glued and then plated on the exterior with clear float glass. There are many pieces that are also single line breaks that are more typical of glass that was properly annealed. This piece is also convex where the center is higher and not flat on the workbench. 3<sup>rd</sup> to the left: This piece of glass shows an erratic break that is typical for glass that has not been properly annealed. On the right above: a better example of the convexity of the glass in some of the pieces.

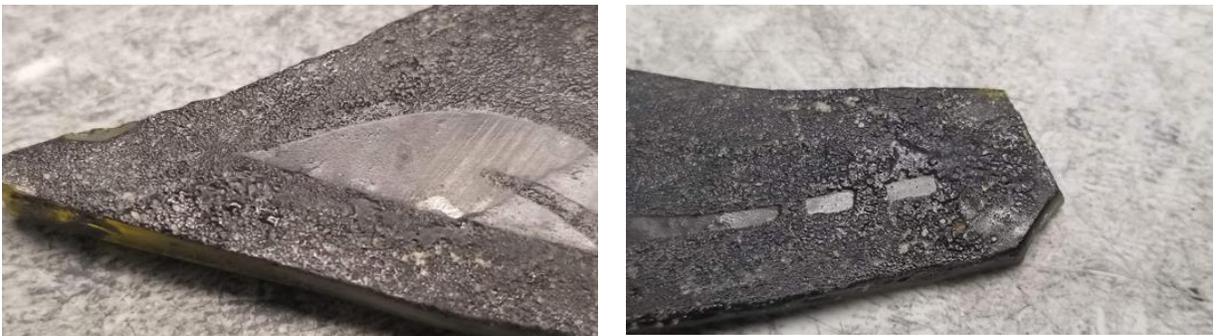
These 2 photos above show how the paint has pits and craters; it should appear as smooth as the glass. It was either not well-fired or is a result of using too much binder in the paint. Given that the pattern of the glass breakage is likely related to the firing, the paint problem is more likely a firing problem too. The result of this is paint that is not fused into the surface of the base glass. All the panels have paint that is not well-fired but is not consistent within each panel of glass. Overtime, the pits and craters can collect dirt which makes cleaning it more important to restore the color. This condition changes the method of cleaning, extra care must be taken not to remove the paint and makes removing the putty from the surface of the glass more difficult.
