PROGRESS ON THE PRESERVATION OF THE REV. AND MRS. J FREDERIC WENCHEL WINDOW

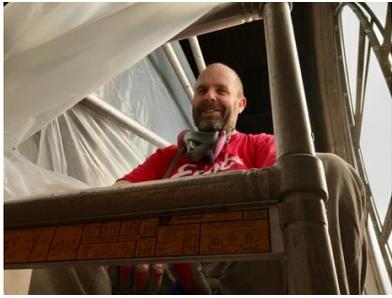
Talking with him that week, he noted that there was more cracked glass than he expected now that he was able to look at it closely and from both sides using the scaffolding. He said it was definitely the right time for us to get the window renovated.

Mr. Goldkuhle, pausing for a photo, during the window removal.

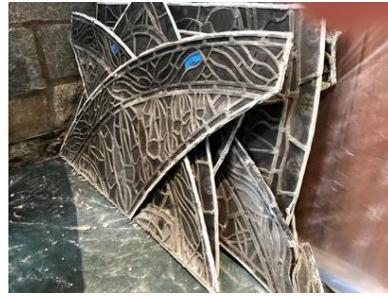
All the panels removed, waiting to be taken out of the church.

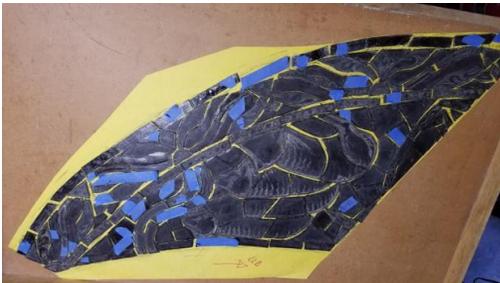
Once he got the window further disassembled in his studio, there was yet more cracked glass than he had expected to see. In addition, the glass in some areas was not flat, but convex; the paint (glazing) in some areas was pitted and not well-fused to the glass. He has repaired the glass. The glass has been cleaned, the pitting makes that more difficult, along with needing to take extra care not to remove the paint.

The worst affected panel, the blue tape corresponds to a broken piece of glass

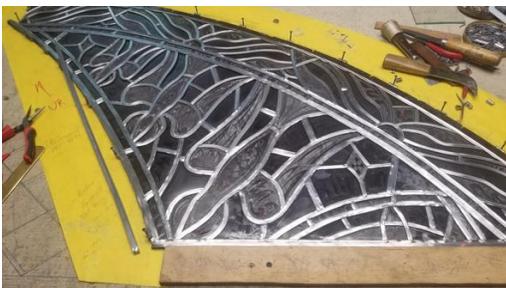
Upper right panel

This past week, he updated us regarding his progress. Four of the 7 window panels have been renovated. He is re-enforcing the window to provide more support for its weight. There will be a layer of tin solder on all lead surfaces not just at the lead joints (which is the usual). This adds weight, but also adds strength. In addition to this, on the exterior face, he will place vertical brass strong backs that will complement the existing interior horizontal round reinforcing bars; essentially sandwiching the window panel between a mesh-like superstructure. Besides this new structure, the window, once reinstalled, will be vented (it wasn't before) which will lessen temperature stress on the window. Both of these maneuvers should help maintain the window for a long time.
