UPDATE ON RESTORATION OF THE CHRIST THE KING WINDOW

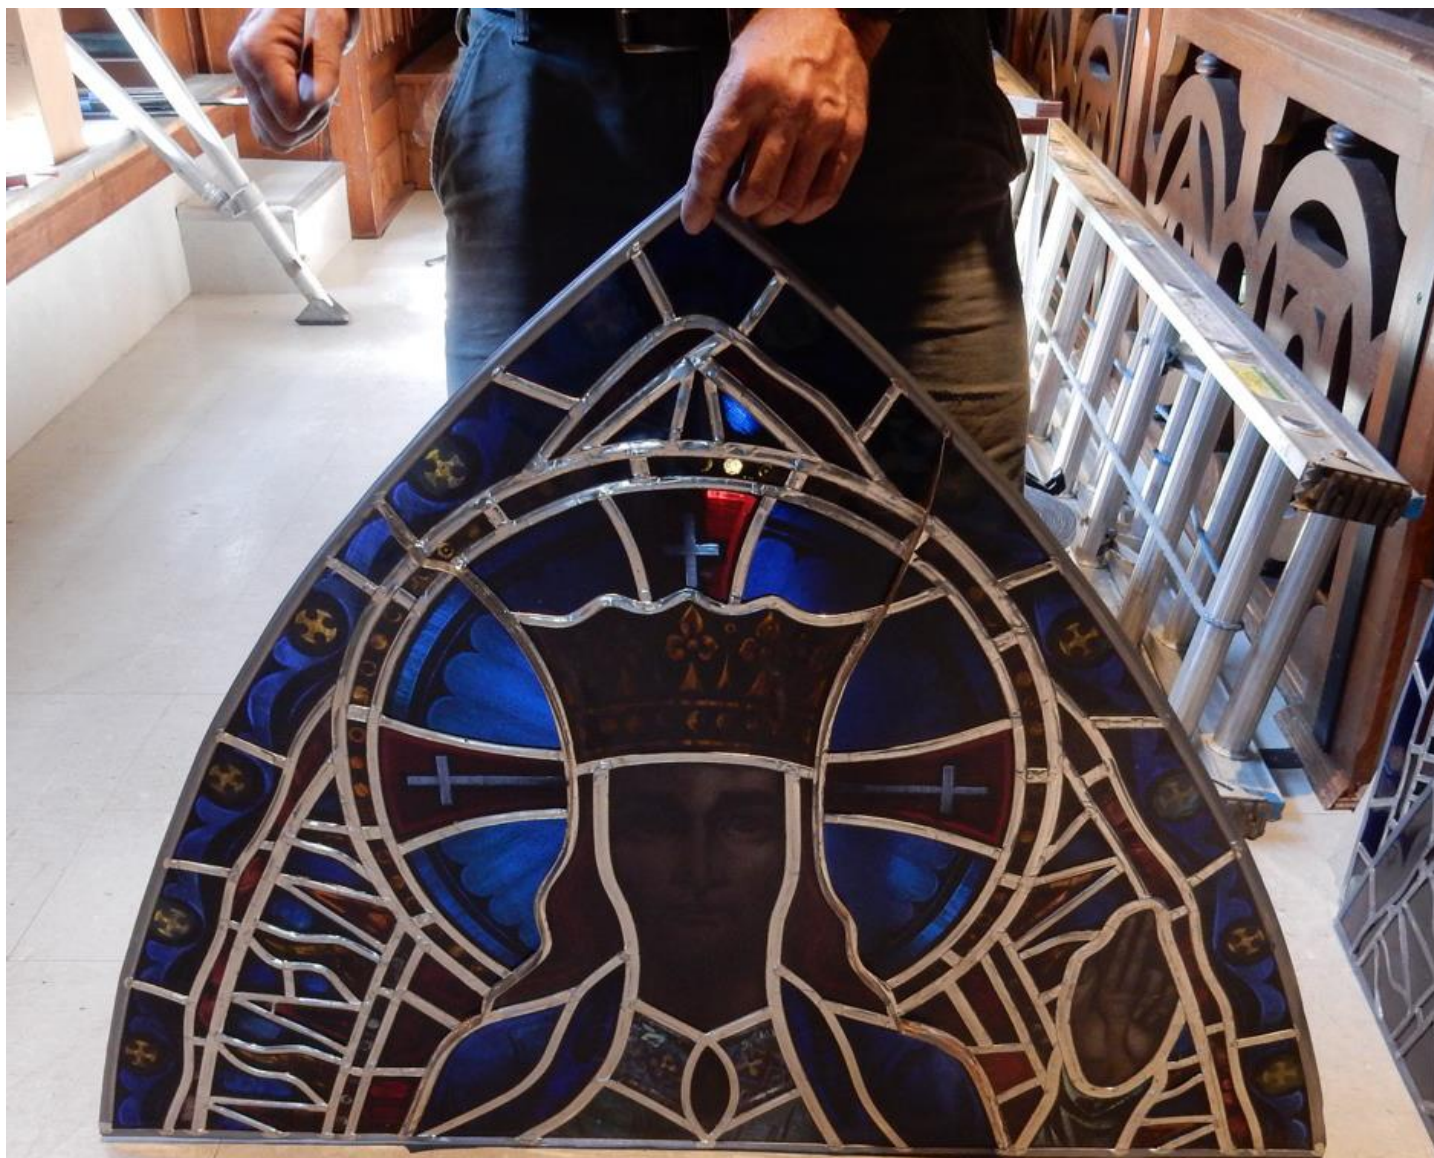
Andrew is showing us the outside surface of the panel. The lead strips (comes) on the outside are reinforced by tin, which is shiny. The tin makes the window more rigid and less likely to buckle. Also, you get a sense of the size of the panel.
